**Flood Control Project Maintenance  
Levee Inspections**  
**LMA District Cover Sheet**  
**Spring 2018 Levee Inspection Results**

**Knights Landing Ridge Drainage District**

**Spring 2018 Levee Inspection Results**

## Levee Inspection Report By Mile - Spring 2018

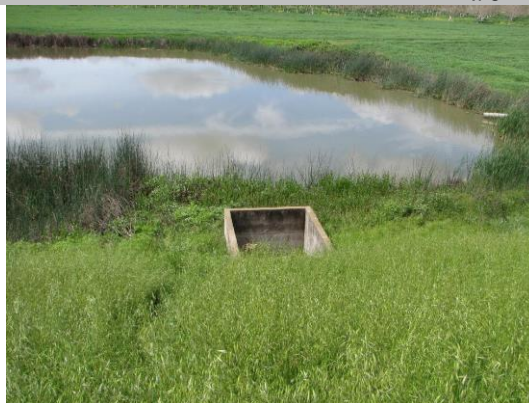
Photo 1 of 3 : UCIP\_SP\_2018\_48010\_21582.jpg

FS\_ID:48010  
DS\_ID:19360  
EP\_NO: 9302  
Repair Type: No Action Needed  
Crossing Status: Found  
UCIP Comments: Pipe has been grouted in place under permit 18987, 2015Pipe completely rusted through on LS slope of levee at toe/headwall of concrete distribution box. Pipe needs replacement or proper abandonment. Pipe not visible at outlet.  
FIELD\_STRUCT\_DESC: \*ABANDONED\* 36-inch corrugated metal drainage pipe through the levee, 27 feet below the crown. Slide gate on the waterside (WS) end. 12-foot by 6-foot concrete box on the landside (LS) end. (36-inch pipe [HLM 1.62] authorized under Automatic Board Order (ABO) issued as Permit No. 9302, 1974 - Barbara Lowe Elliott; 36-inch pipe abandoned by removing ends and pumping pipe full of concrete under Permit No. 18987, 2016 - Knaggs Ranch, LLC, care of John Brennan). [Additional Reference(s): DWR Levee Log, 1990. USACE Sacramento O&M Manual 127, June 1953, (Station 0+30)].

Concrete distribution box on LS toe.

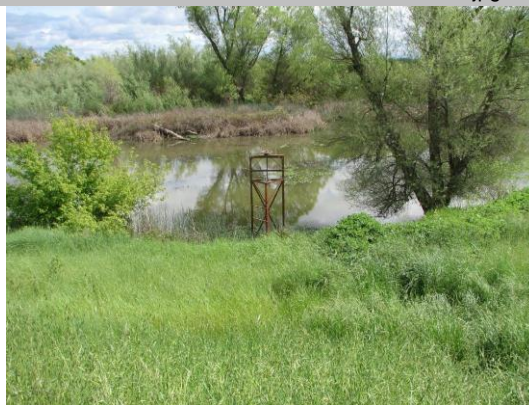
Photo 2 of 3 : UCIP\_SP\_2018\_48010\_21581.jpg

Slide gate on metal stand on WS toe. Pipe opening not visible.

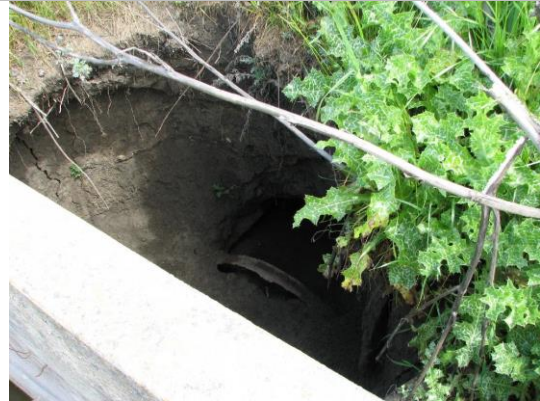
Photo 3 of 3 : UCIP\_SP\_2018\_48010\_21580.jpg

Comment Code					
Inspector Comment					
FS_ID:48010 DS_ID:19360 EP_NO: 9302 Repair Type: No Action Needed Crossing Status: Found UCIP Comments: Pipe has been grouted in place under permit 18987, 2015Pipe completely rusted through on LS slope of levee at toe/headwall of concrete distribution box. Pipe needs replacement or proper abandonment. Pipe not visible at outlet. FIELD_STRUCT_DESC: *ABANDONED* 36-inch corrugated metal drainage pipe through the levee, 27 feet below the crown. Slide gate on the waterside (WS) end. 12-foot by 6-foot concrete box on the landside (LS) end. (36-inch pipe [HLM 1.62] authorized under Automatic Board Order (ABO) issued as Permit No. 9302, 1974 - Barbara Lowe Elliott; 36-inch pipe abandoned by removing ends and pumping pipe full of concrete under Permit No. 18987, 2016 - Knaggs Ranch, LLC, care of John Brennan). [Additional Reference(s): DWR Levee Log, 1990. USACE Sacramento O&M Manual 127, June 1953, (Station 0+30)]. FS Date: 5/16/2016 3:59:29 PM

Pipe failure at connection to concrete box on LS toe.

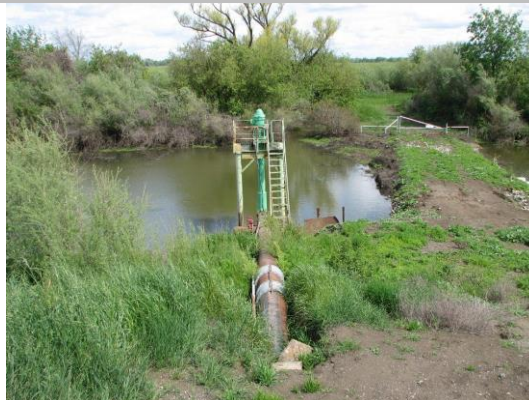
Photo 1 of 3 : UCIP\_SP\_2018\_11064\_18426.jpg

Comment Code					
Inspector Comment					
FS_ID:11064 DS_ID:19361 EP_NO: 9302 Repair Type: Non-Urgent Crossing Status: Found UCIP Comments: Pipe exposed on WS slope in trench may need to be backfilled to prevent erosion under pipe. FIELD_STRUCT_DESC: 20-inch steel irrigation pipe through the levee, 8.8 feet below the crown. Pump on a steel pile structure at the waterside (WS) toe. Siphon breaker in a 12-inch steel riser on the landside (LS) slope. Possible butterfly valve at the LS toe. (Permit No. 9302, 1974 - Barbara Lowe Elliott). [Additional Reference(s): DWR Levee Log, 1990. USACE Sacramento O&M Manual 127, June 1953, (Station 32+94)]. FS Date: 4/5/2013

Pump on pile at WS toe with pipe in open trench on LS slope.

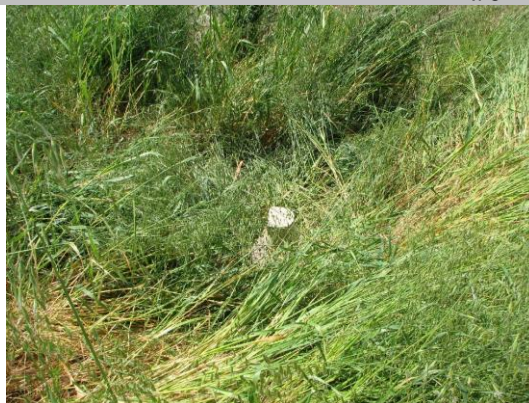
Photo 2 of 3 : UCIP\_SP\_2018\_11064\_18425.jpg

Siphon breaker in 12-inch steel riser on LS slope.

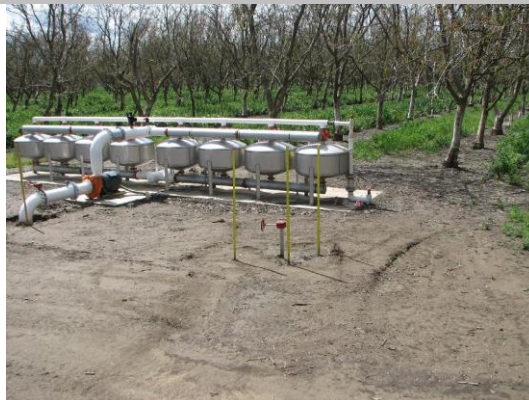
Photo 3 of 3 : UCIP\_SP\_2018\_11064\_18424.jpg

Possible butterfly valve off LS toe.

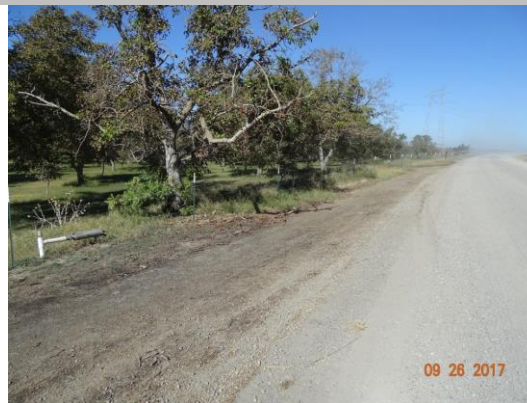
Photo 1 of 1 : SP\_2018\_NA0008\_256\_26\_20180306\_00008.jpg

View of fence on the landside slope. Fall 2017.

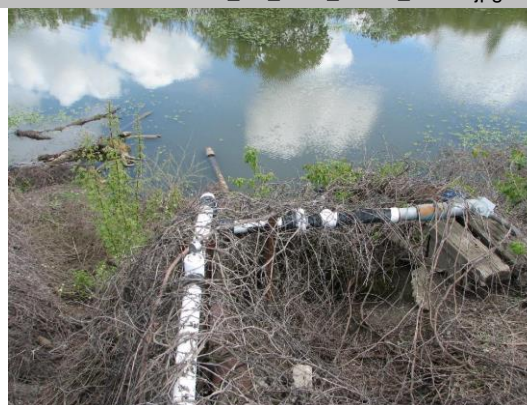
Photo 1 of 3 : UCIP\_SP\_2018\_11065\_18429.jpg

Comment Code					
Inspector Comment					
FS_ID:11065 DS_ID:19362 EP_NO: 9305 Repair Type: Non-Urgent Crossing Status: Found UCIP Comments: Slope on WS shoulder appears to be eroding at pipes exit from levee. 36-inch conc riser on LS is filled with mud. FIELD_STRUCT_DESC: 10-inch steel irrigation pipe through the levee, 5.8 feet below the crown. Pump at the waterside (WS) toe. 36-inch concrete standpipe at the landside (LS) toe. (Permit No. 9305, 1974 - Albert L. Bacchini). 5-inch steel pipe sleeved through the 10-inch pipe. Annular space grouted. (Permit No. 6076, 1968 - Albert L. Bacchini). [Additional Reference(s): DWR Levee Log, 1990. USACE Sacramento O&M Manual 127, June 1953, (Station 47+00) (11-inch pipe listed)]. FS Date: 4/5/2013

Pump on WS shoulder overgrown and may be abandoned.

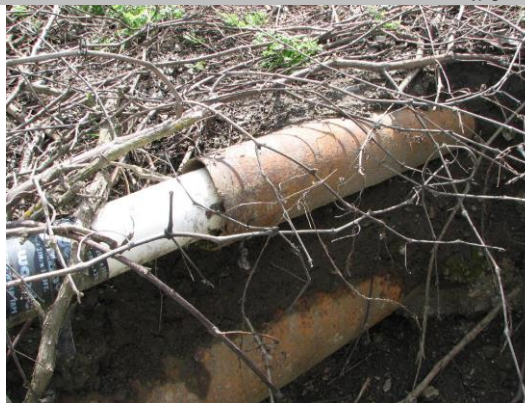
Photo 2 of 3 : UCIP\_SP\_2018\_11065\_18428.jpg

Erosion at pipes exit from levee on WS shoulder.

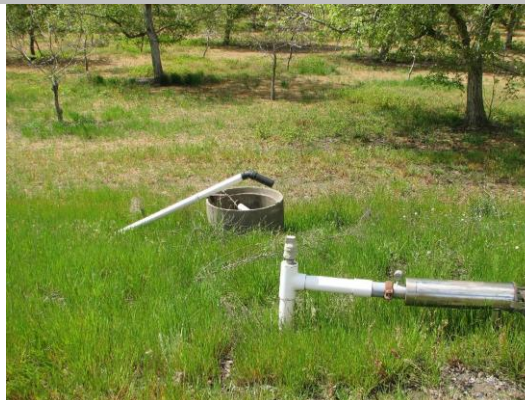
Photo 3 of 3 : UCIP\_SP\_2018\_11065\_18427.jpg

36-inch Concrete standpipe at LS toe

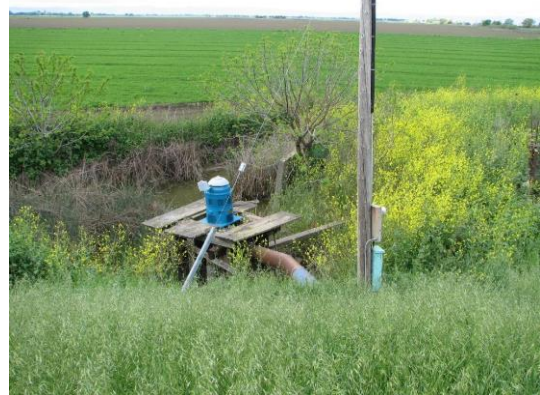
Photo 1 of 1 : UCIP\_SP\_2018\_11067\_18431.jpg

Comment Code					
Inspector Comment					
FS_ID:11067					
DS_ID:19364					
EP_NO: 9307					
Repair Type: Non-Urgent					
Crossing Status: Found					
UCIP Comments: Siphon breaker on LS burried or broken off and missing.					
FIELD_STRUCT_DESC: 1 of 2: 14-inch steel drainage pipe through the levee, 5.4 feet below the crown. Pump house on a pile structure at the landside (LS) toe. Siphon breaker on the LS slope. Service pole and anchor at the LS toe. (14-inch pipe [HLM 2.62] authorized under Automatic Board Order (ABO) issued as Permit No. 9307, 1974 - Azalene E. Lowe; a 12-foot section of an existing 14-inch pipe on LS replaced and name change under Permit No. 9307-1, 2016 - Ann Grube). [Additional Reference(s): DWR Levee Log, 1990. USACE Sacramento O&M Manual 127, June 1953, (Station 123+25)].					
FS Date: 4/5/2013

Pump and pipe on LS toe.

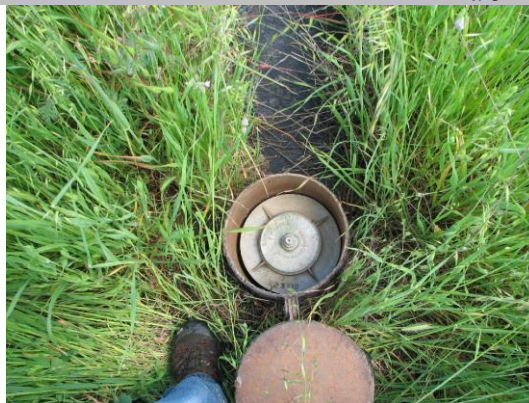
Photo 2 of 3 : UCIP\_SP\_2018\_16106\_27212.jpg

Siphon breaker on WS slope

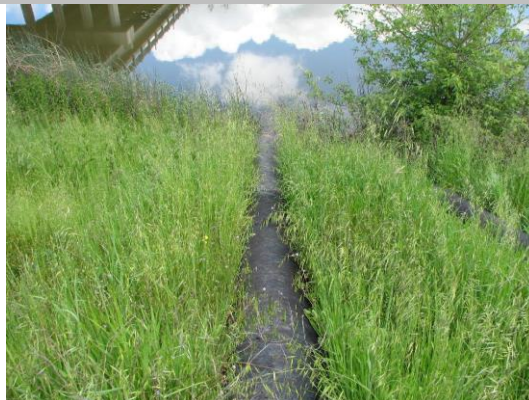
Photo 3 of 3 : UCIP\_SP\_2018\_16106\_27214.jpg

Pipe on WS slope.

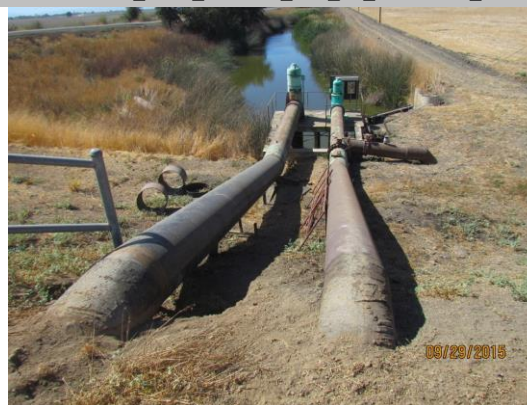
Photo 1 of 2 : SP\_2018\_NA0008\_256\_18\_20180306\_00003.jpg

LM Start	2.70	Rating **	M	Issue No.	18
LM End	2.70	Issue Type +	En	Location *	LS
Category	Earthen Levee			GPS Latitude/Longitude	
				Start	End
Item	Encroachments			38.748837 °	38.748837 °
				-121.694823 °	-121.694823 °
DWR ID	DWR_NA0008_01_f_ 2015_18				
Comment Code					
DE : Debris					
Inspector Comment					
Portion of the pipe seems to be replaced and the abandoned pipe is left at the toe of the landward side of the levee.

The dark portion on the left pipe seems to have been replaced with a new pipe. Fall 2015.

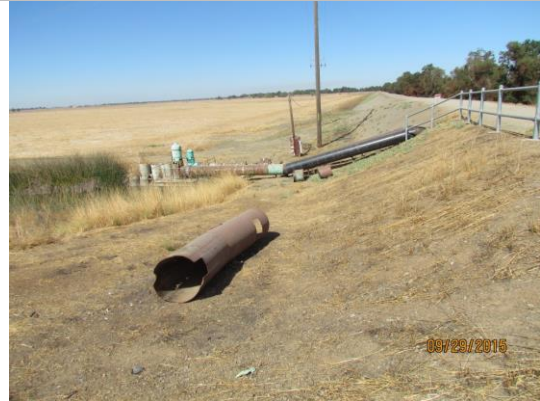
Photo 2 of 2 : SP\_2018\_NA0008\_256\_18\_20180306\_00004.jpg

View of the abandoned pipe at the toe of levee on the landward side.  
Fall 2015.

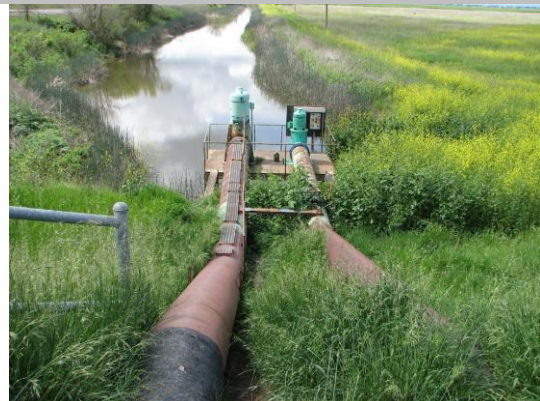
Photo 1 of 2 : UCIP\_SP\_2018\_11244\_18603.jpg

Pump on steel pile structure at LS toe with pipe on slope.

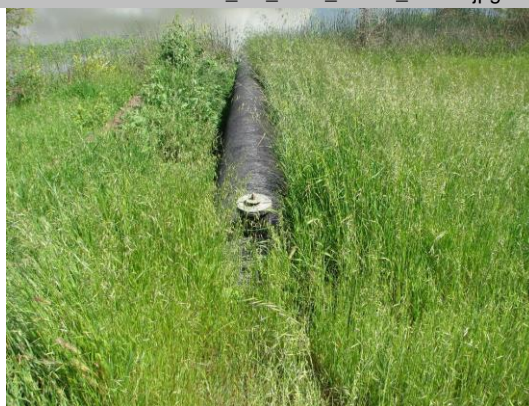
Photo 2 of 2 : UCIP\_SP\_2018\_11244\_18602.jpg

Siphon breaker on pipe at WS slope.

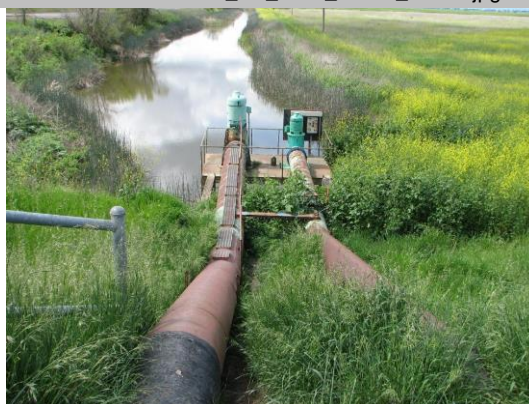
Photo 1 of 2 : UCIP\_SP\_2018\_11247\_18605.jpg

Pump on steel pile structure with butterfly valve and pipe on LS slope.

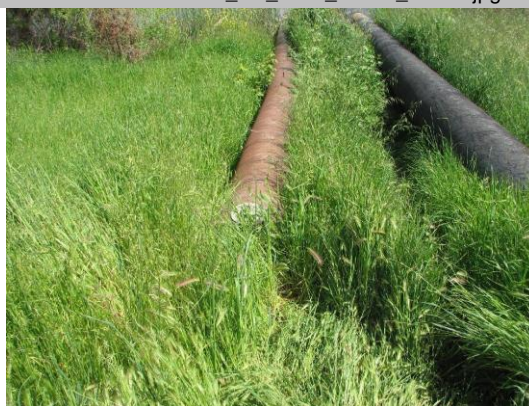
Photo 2 of 2 : UCIP\_SP\_2018\_11247\_18604.jpg

Siphon breaker on pipe at WS shoulder.

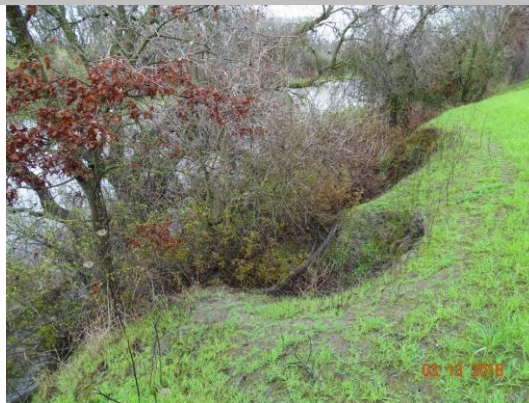
Photo 1 of 3 : SP\_2018\_NA0008\_256\_20\_20180313\_00045.jpg

LM Start	3.50	Rating **	U	Issue No.	20
LM End	3.50	Issue Type +	Ma	Location *	WS
Category	Earthen Levee			GPS Latitude/Longitude	
				Start	End
Item	Erosion / Bank Caving			38.759910 °	38.759910 °
				-121.696920 °	-121.696920 °
DWR ID	DWR_NA0008_01_f_2015_20				
Comment Code					
E2 : Schedule repair of erosion site prior to the next inspection.					
Inspector Comment

Updated view of erosion on the waterside slope. Spring 2018.

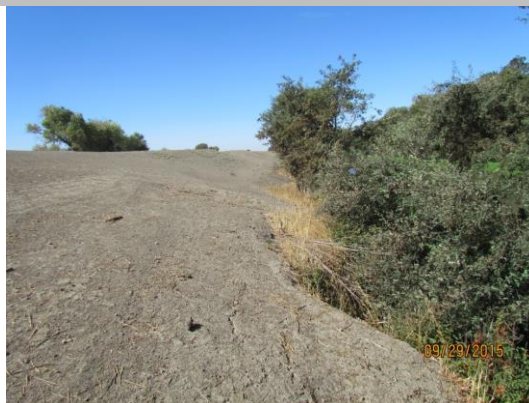
Photo 2 of 3 : SP\_2018\_NA0008\_256\_20\_20180306\_00006.jpg

View of the erosion on the waterward side of the levee looking upstream. Fall 2015.

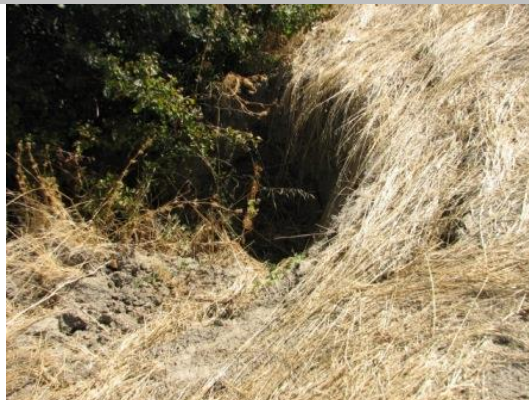
Photo 3 of 3 : SP\_2018\_NA0008\_256\_20\_20180306\_00005.jpg

Deep erosion at the bottom of the waterside slope 3-4 foot cut. Fall 2013

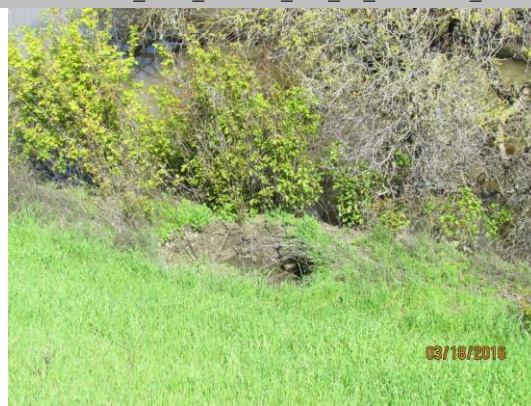
Photo 1 of 1 : SP\_2018\_NA0008\_256\_30\_20180306\_00011.jpg

LM Start	3.78	Rating **	M	Issue No.	30
LM End	3.78	Issue Type +	Ma	Location *	WS
Category	Earthen Levee			GPS Latitude/Longitude	
				Start	End
Item	Erosion / Bank Caving			38.762886 °	38.762886 °
				-121.700406 °	-121.700406 °
DWR ID	DWR_NA0008_01_s_2017_30				
Comment Code					
E2 : Schedule repair of erosion site prior to the next inspection.					
Inspector Comment					
Hole is at the toe of the levee on the waterward side.

View of the erosion at the toe of the levee on the waterward side. Spring 2016.

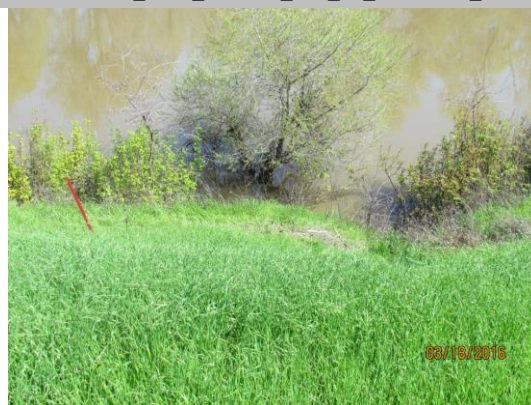
Photo 1 of 1 : SP\_2018\_NA0008\_256\_31\_20180306\_00012.jpg

LM Start	3.86	Rating **	M	Issue No.	31
LM End	3.86	Issue Type +	Ma	Location *	WS
Category	Earthen Levee			GPS Latitude/Longitude	
				Start	End
Item	Erosion / Bank Caving			38.763751 °	38.763751 °
				-121.701398 °	-121.701398 °
DWR ID	DWR_NA0008_01_s_2018_31				
Comment Code					
E1 : Note and monitor erosion site.					
Inspector Comment					
Erosion at the toe of the levee. LMA is monitoring erosion with stakes.

View of the erosion at the toe of the levee on the waterward side. Spring 2016.

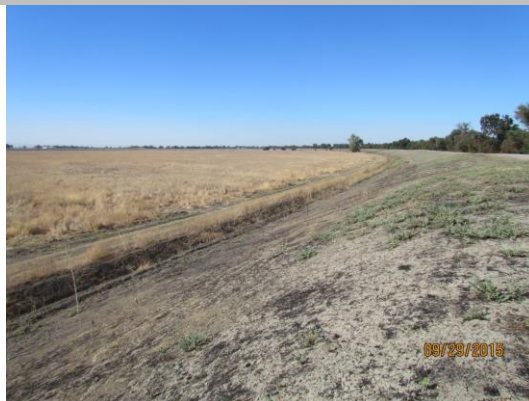
Photo 1 of 1 : SP\_2018\_NA0008\_256\_22\_20180306\_00007.jpg

View of the ditch on the landward side of the levee looking upstream.  
Fall 2015.

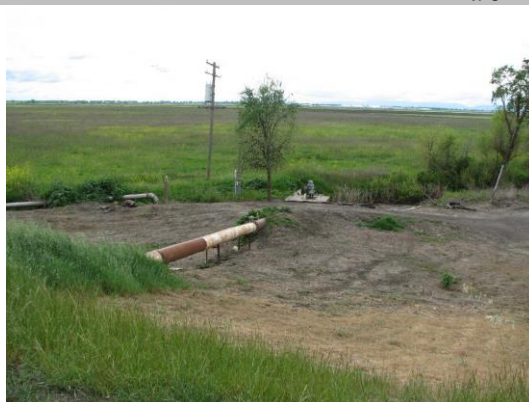
Photo 1 of 3 : UCIP\_SP\_2018\_11264\_18622.jpg

Pump and pipe on LS toe.

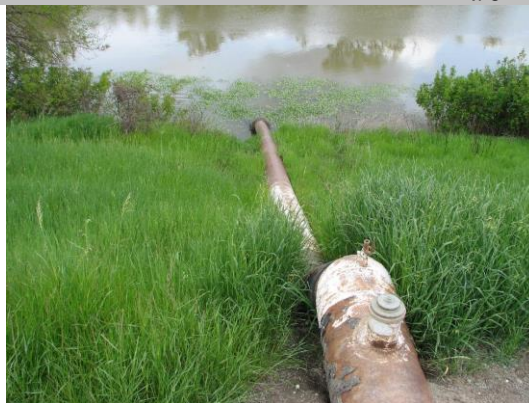
Photo 2 of 3 : UCIP\_SP\_2018\_11264\_18621.jpg

Siphon and air vent on WS shoulder.

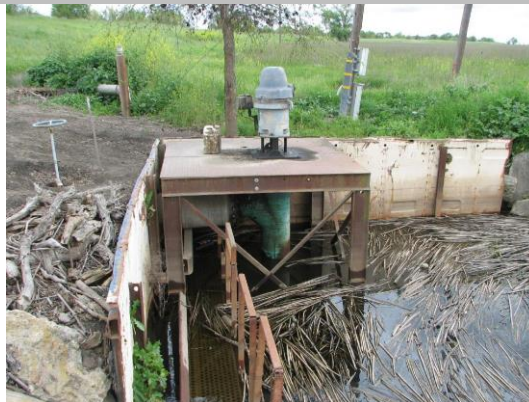
Photo 3 of 3 : UCIP\_SP\_2018\_11264\_18620.jpg

Pump on Steel pile structure with slide gate at LS toe.

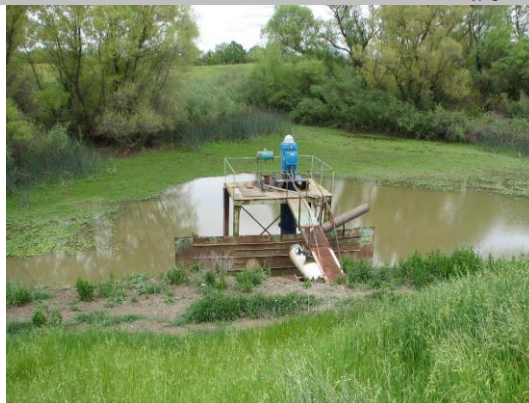
Photo 1 of 3 : UCIP\_SP\_2018\_41068\_18643.jpg

Comment Code					
Inspector Comment					
FS_ID:41068 DS_ID:19397 EP_NO: 5276 Repair Type: Non-Urgent Crossing Status: Found UCIP Comments: Pipe appears abandoned at this time. FIELD_STRUCT_DESC: 2 of 2: 20-inch steel irrigation pipe through the levee, 4.9 feet below the crown. Vertical pump unit on pile structure in stream. Siphon breaker on the landside (LS) shoulder in a 16-inch steel riser. Flap gate on the LS end. Pipe discharges into an irrigation ditch on the LS. Steel plate welded over end of pipe at pump structure. (Replaced an existing 18-inch pipe at this location under Permit No. 5276, 1966 - Reclamation District No. 730). [Additional Reference(s): DWR Levee Log, 1990]. FS Date: 4/5/2013

Pump on steel structure at WS toe.

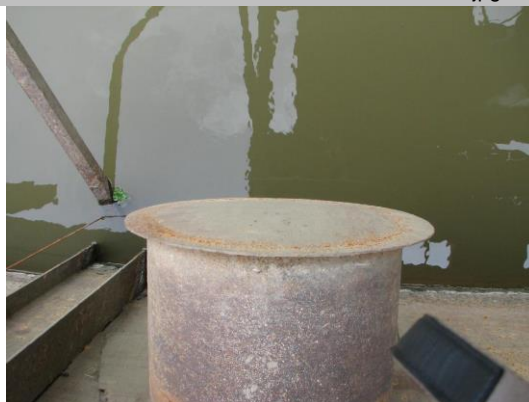
Photo 2 of 3 : UCIP\_SP\_2018\_41068\_18642.jpg

Steel plate welded over pipe end at pump platform.

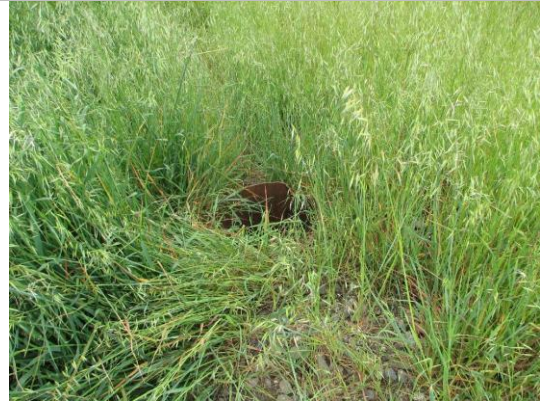
Photo 3 of 3 : UCIP\_SP\_2018\_41068\_18641.jpg

Siphon breaker buried inside 16-inch steel riser on LS shoulder.

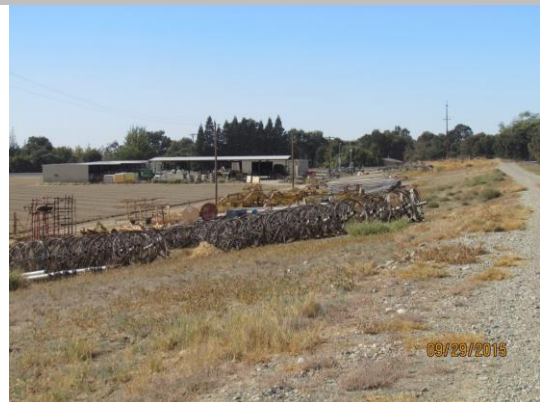
Photo 1 of 2 : SP\_2018\_NA0008\_256\_7\_20180306\_00001.jpg

View of the equipment on the landward side of the levee looking upstream. Fall 2015.

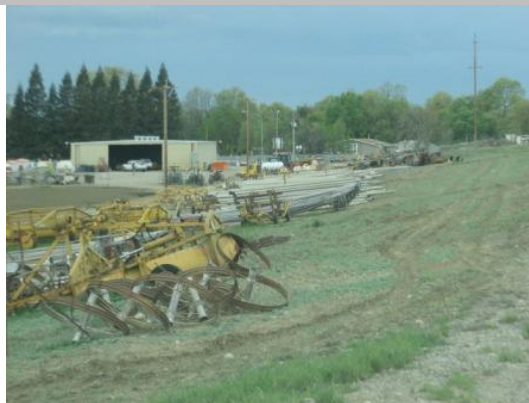
Photo 2 of 2 : SP\_2018\_NA0008\_256\_7\_20180306\_00002.jpg

A current view of the equipment on the levee slope. Spring 2014

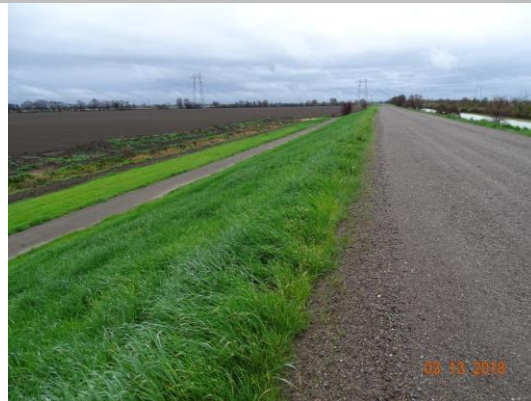
Photo 1 of 1 : SP\_2018\_NA0008\_257\_21\_20180313\_00023.jpg

View of vegetation on the landside slope. Spring 2018.

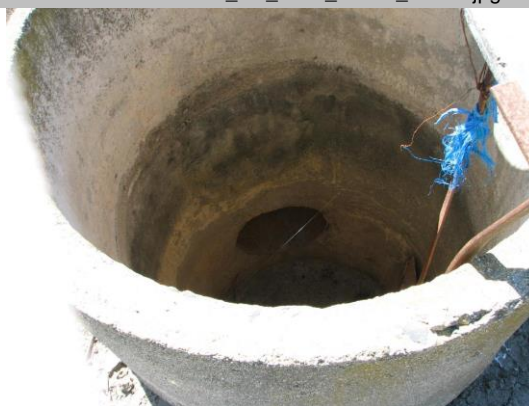
Photo 1 of 3 : UCIP\_SP\_2018\_52536\_18708.jpg

FS\_ID:52536  
DS\_ID:19370  
EP\_NO: 9320  
Repair Type: Non-Urgent  
Crossing Status: Found  
UCIP Comments: 09/27/2017 Received updated information from DWR levee inspector, Zachary Jojola, confirming that this crossing is still abandoned. Recommend pipe be abandoned properly according to Title 23 requirements. Updated photos have been added to this report. (DWR UCIP - O. Magana)04/09/2013 Appears abandoned as pump is missing from platform. (DWR UCIP - W. Wylie)  
FIELD\_STRUCT\_DESC: 16-inch steel irrigation pipe through the levee, 2.8 feet below the crown. Pipe discharges into a 36-inch concrete standpipe at the levee toe. Pump on steel pile structure in stream with metal walkway. Two service poles on the waterside (WS) slope. (Automatic Board Order (ABO) issued as Permit No. 9320, 1974 - Ralph W. Pollock). [Additional Reference(s): DWR Levee Log, 1990. USACE Sacramento O&M Manual 127, June 1953, (Station 52+00) (15-inch pipe listed)].

Pipe at 36-inch Concrete standpipe on LS toe.

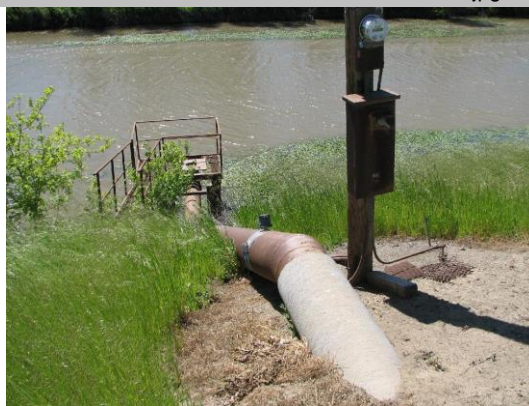
Photo 2 of 3 : UCIP\_SP\_2018\_52536\_18707.jpg

Pump platform and walkway on WS toe.

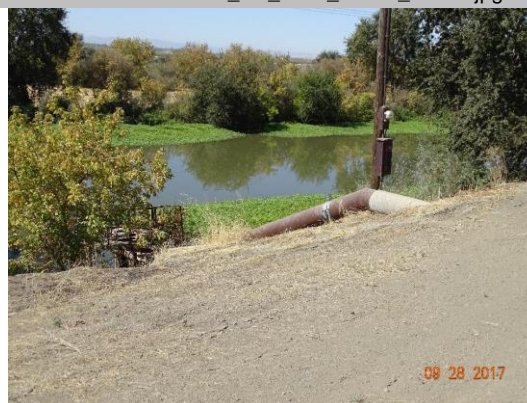
Photo 3 of 3 : UCIP\_SP\_2018\_52536\_77500.jpg

WS view: pipe and electrical panel visible.

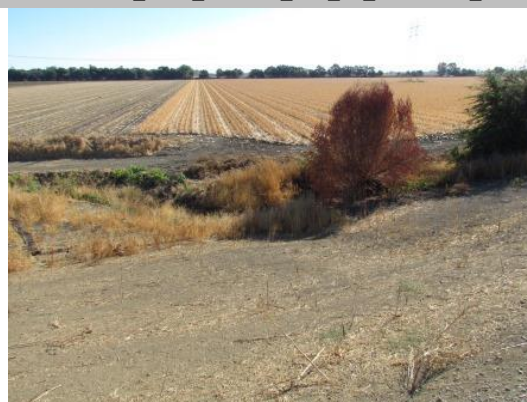
Photo 1 of 1 : SP\_2018\_NA0008\_257\_22\_20180306\_00007.jpg

View of a ditch near landside toe. Fall 2016.

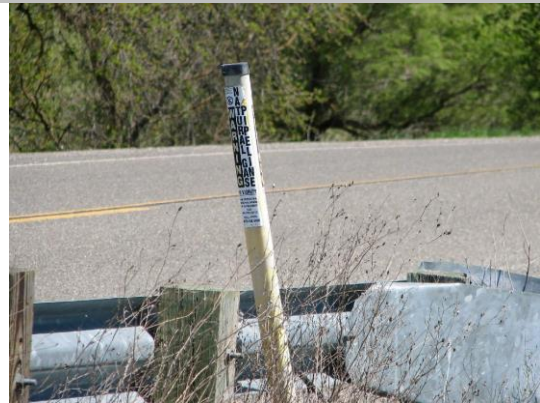
Photo 1 of 3 : UCIP\_SP\_2018\_50106\_18700.jpg

Sign on LS shoulder may indicate location of pipe, or it may indicate where pipe crosses approach ramp to bridge.

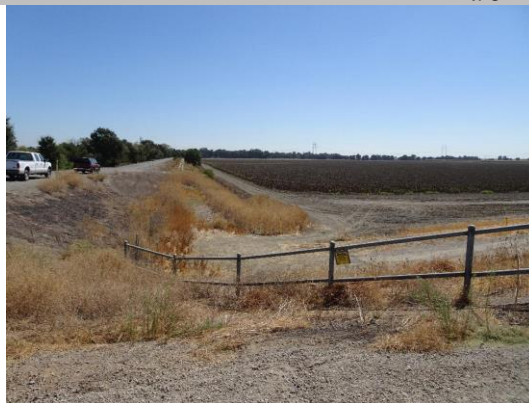
Photo 2 of 3 : UCIP\_SP\_2018\_50106\_75964.jpg

View from the levee crown looking toward the LS of the levee. gas line marker signs are visible marking an alignment parallel to the levee.

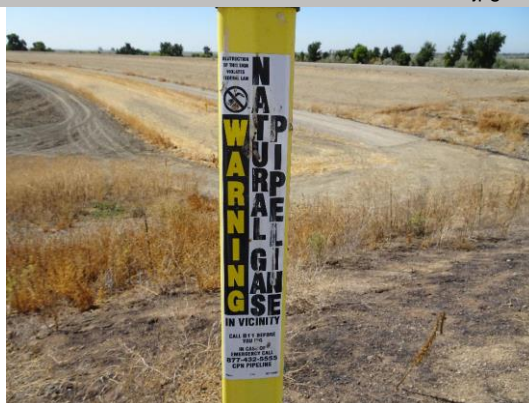
Photo 3 of 3 : UCIP\_SP\_2018\_50106\_75965.jpg

View of the marker signs information

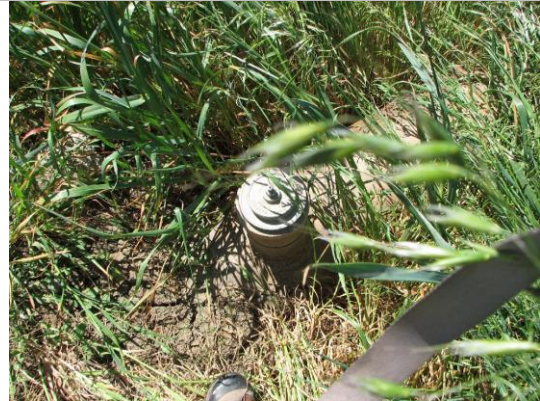
Photo 3 of 3 : UCIP\_SP\_2018\_11293\_18673.jpg

16-inch pipe with siphon breaker on WS shoulder.

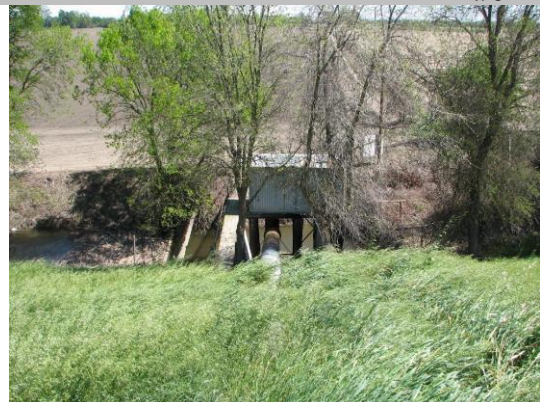
Photo 1 of 3 : UCIP\_SP\_2018\_11291\_18669.jpg

Pumphouse at LS toe.

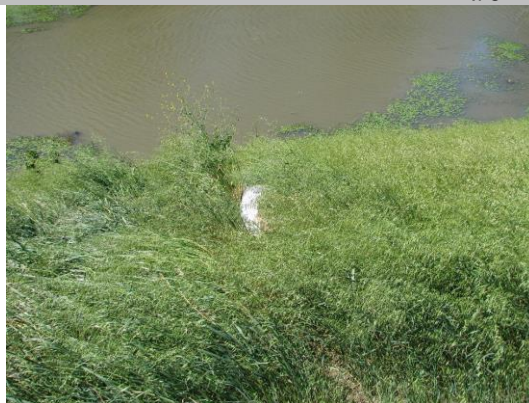
Photo 2 of 3 : UCIP\_SP\_2018\_11291\_18668.jpg

Pipe in grass on WS shoulder.

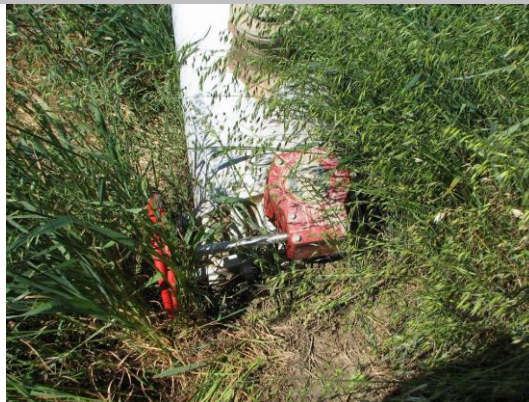
Photo 3 of 3 : UCIP\_SP\_2018\_11291\_18667.jpg

Siphon breaker and butterfly valve on WS shoulder.

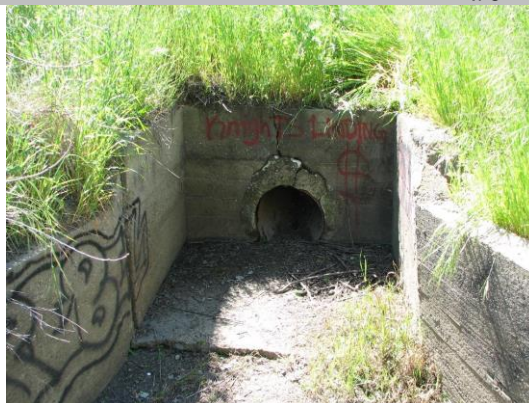
Photo 3 of 3 : UCIP\_SP\_2018\_11289\_18663.jpg

Concrete headwall and distribution box at outlet on LS toe. Pipe heavily corroded.

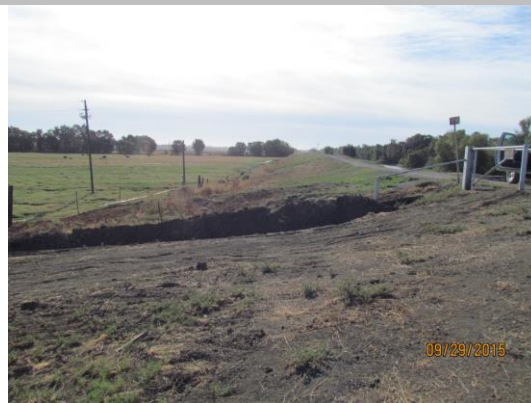
Photo 1 of 3 : SP\_2018\_NA0008\_257\_18\_20180306\_00004.jpg

Perspective view of the ditch on the landward slope of the levee looking downstream. Fall 2015.

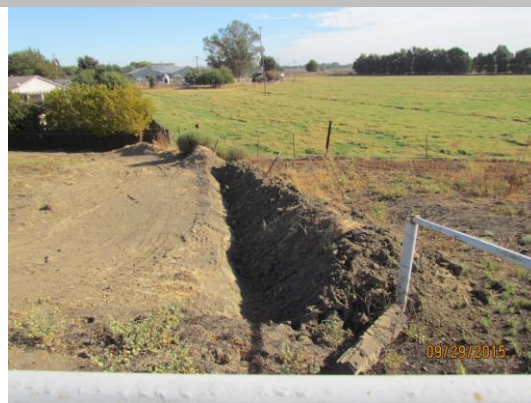
Photo 2 of 3 : SP\_2018\_NA0008\_257\_18\_20180306\_00005.jpg

The ditch is dug onto the landward slope of the levee. Fall 2015.

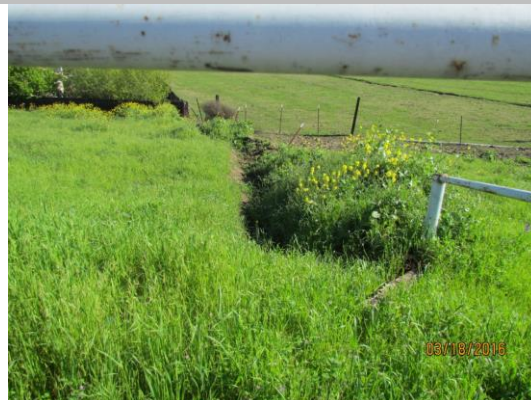
Photo 3 of 3 : SP\_2018\_NA0008\_257\_18\_20180306\_00006.jpg

View of the ditch on the landward slope of the levee. Spring 2016.

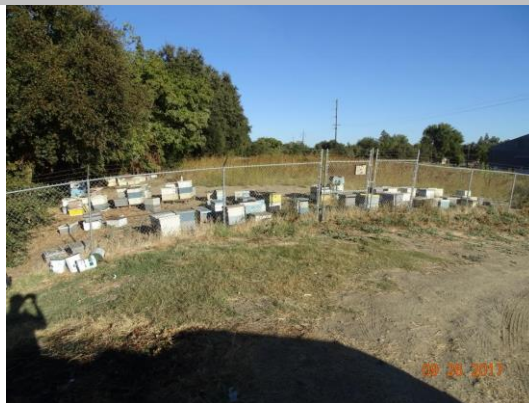
Photo 1 of 2 : SP\_2018\_NA0008\_257\_1\_20180306\_00001.jpg

View of the fence on the crown. Fall 2017.

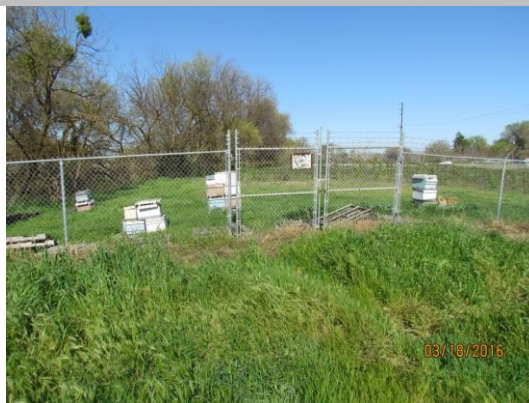
Photo 2 of 2 : SP\_2018\_NA0008\_257\_1\_20180306\_00002.jpg

View of the fence on the crown of the levee looking upstream. Spring 2018.
